VARIOUS DOCK LEVELER ISSUES:

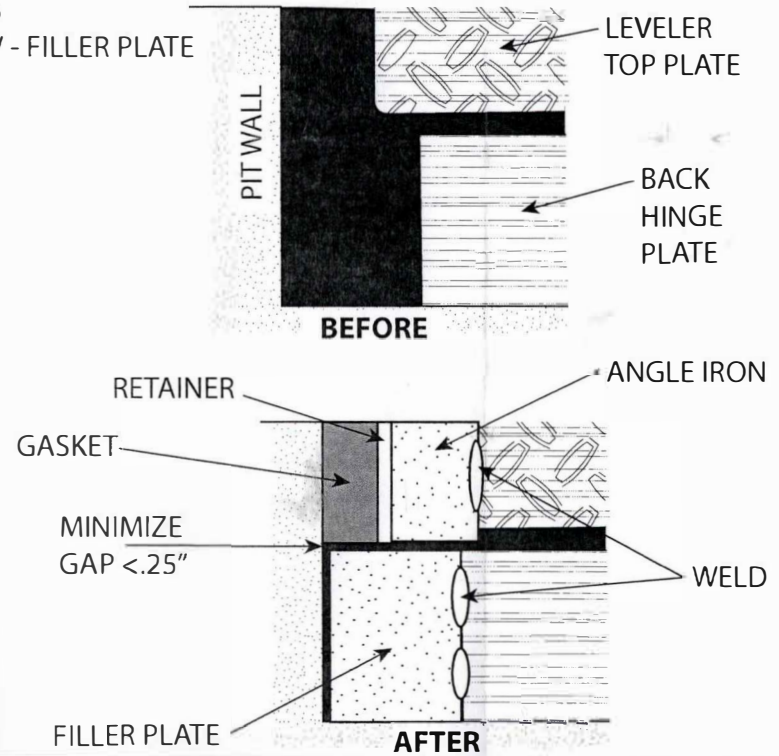
DETAIL B
TOP VIEW - FILLER PLATE
